Nuclear Ship SAVANNAH

Radiological and Non-Radiological Spaces Characterization Survey Report

CONTRACT No.: DTMA1C05013

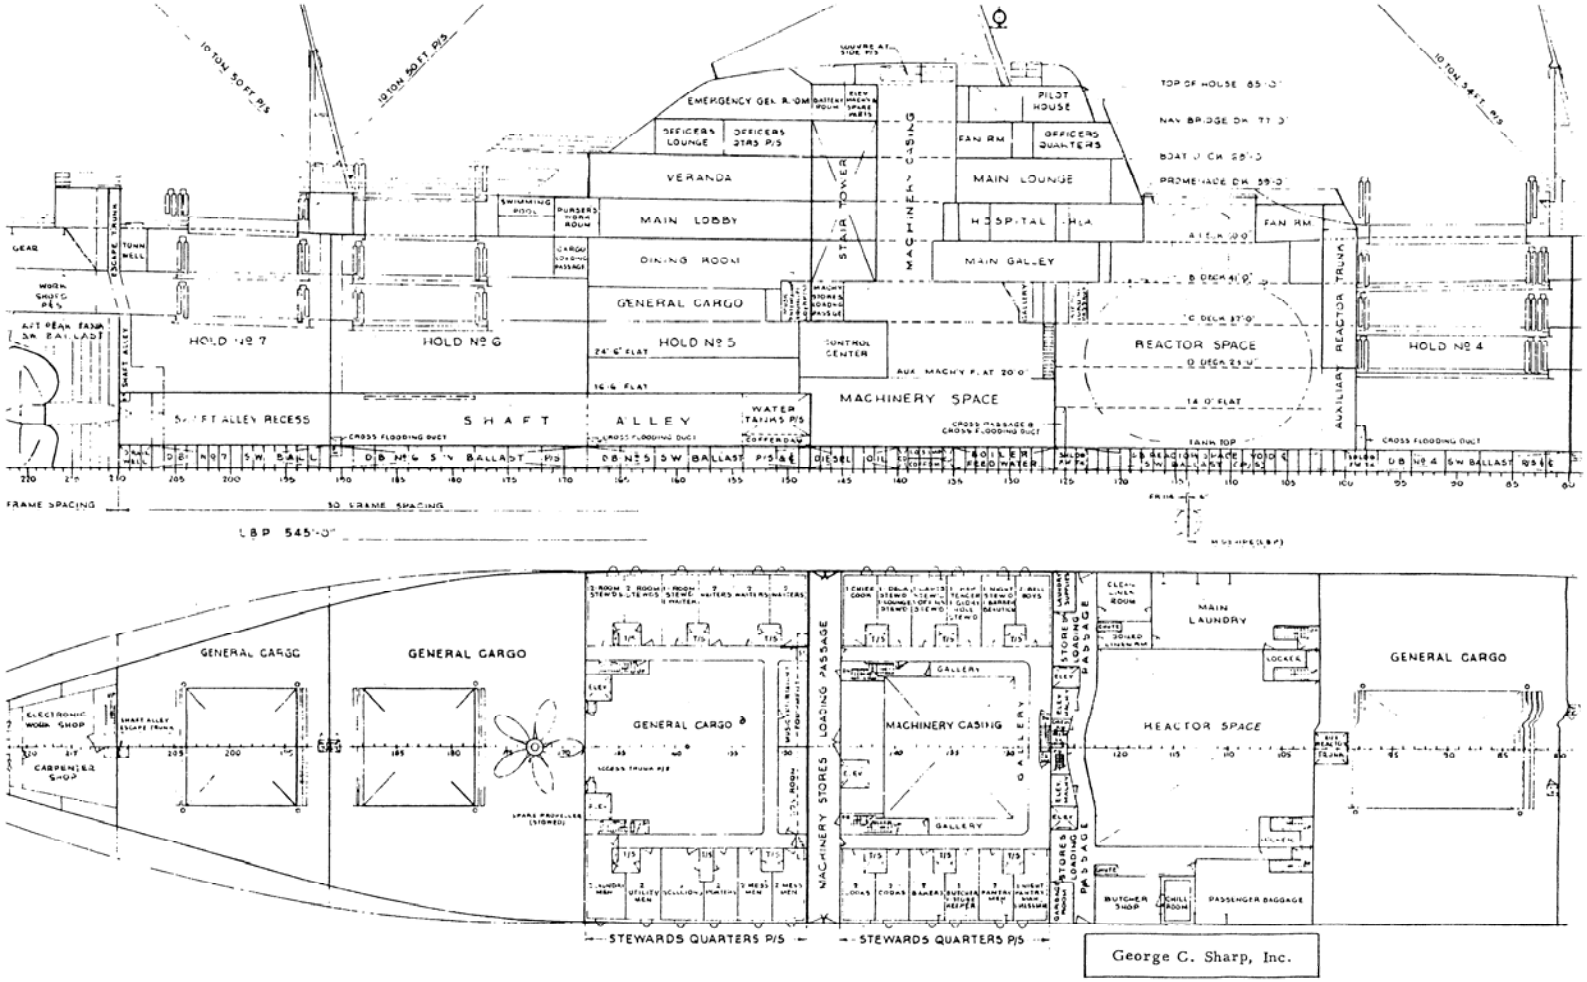
Figure 5A.4-1
N/S SAVANNAH Cross Section, Frames 80–270

Table 5A.4-1 provides a summary of radiological condition found during the evaluation of radiological areas excluding containment. The values listed are maximums. Figure 5A.4-1 provides a cross-sectional view of the NSS radiological area. Brief summaries are provided below with detailed information on the Survey Sheets in Appendix C.

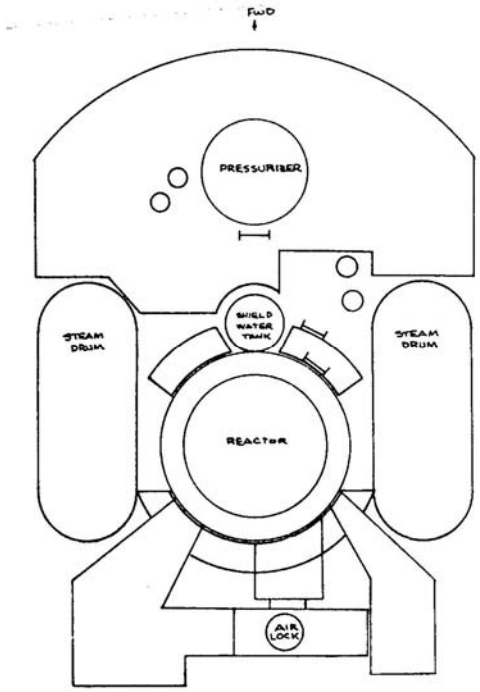
Figure 5A.6-2
Primary Containment Level 1 (Top)

The aft area of 1st level general area dose rate is 0.1–0.5 mR/hour. Next to and forward of the reactor, dose rates vary, with the highest being on the starboard side of the pressurizer at 0.7 mR/hour. Radiological contamination found in several locations <1000 dpm/100cm^2. One location to right of pressurizer has radiological contamination at 1200 dpm/100cm^2. See survey numbers NSS-0087, NSS-0079, and NSS-0083.

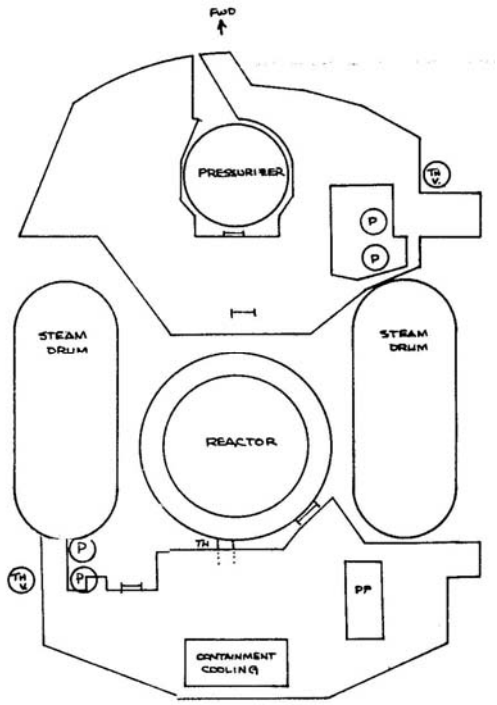
Figure 5A.6-3
Primary Containment Level 2

Dose rates on Level 2 vary 0.1–3 mR/hour. Highest reading is forward starboard near steam drum. No radiological contamination was found. See survey number NSS-0084.

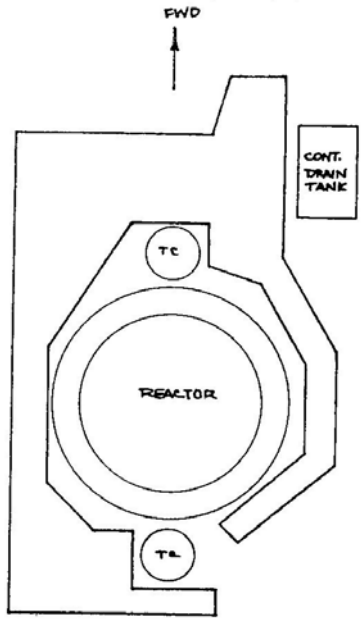
Figure 5A.6-5
Primary Containment Level 4 (Bottom)

General area dose rate was 1–3 mR/hour. No radiological contamination was found. See survey number NSS-0082.
